New insights into hydrogen-assisted intergranular cracking in nickel

ABSTRACT

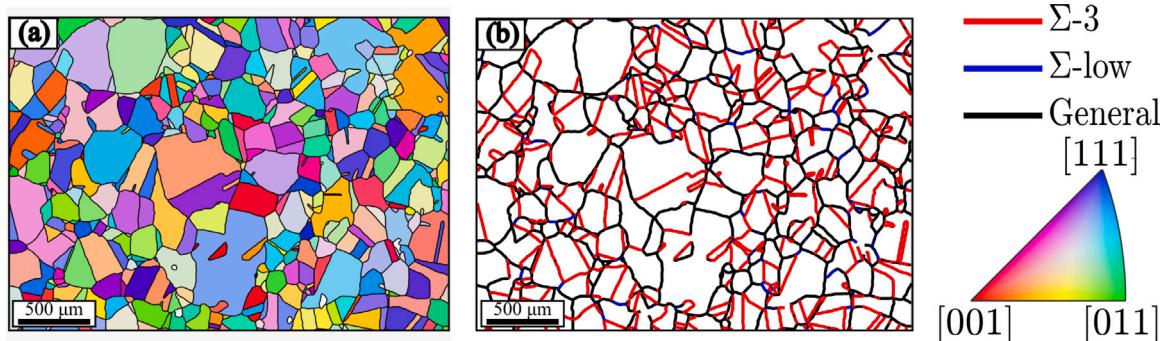
Fig. 1. Baseline microstructure: (a) IPF map and (b) three GB categories showing Σ -3 in red, other Σ -low in blue and general in black. (For interpretation of the references to color in this figure legend, the reader is referred to the web version of this article.)

All experiments were performed on 99.9 wt% pure nickel procured as a 20 mm thick cold-rolled plate. The as-received material was annealed at 950 °C for 1 h, resulting in the baseline microstructure shown in Fig. 1, with equiaxed grains and an average size of $101 \pm 7 \mu\text{m}$.

The Σ value of GBs in the gauge region was characterized following the criteria described in Appendix, as shown in Fig. 1. The GBs were then classified into Σ -3, Σ -low ($3 < \Sigma \leq 29$) and general GBs ($\Sigma > 29$, and random GBs). The fractions of these three groups, given in terms of the number of GB segments (where each GB segment has identical misorientation), reflect the population of GBs in the annealed specimens. These fractions, obtained after heat treatment but before deformation, are considered the baseline microstructure.

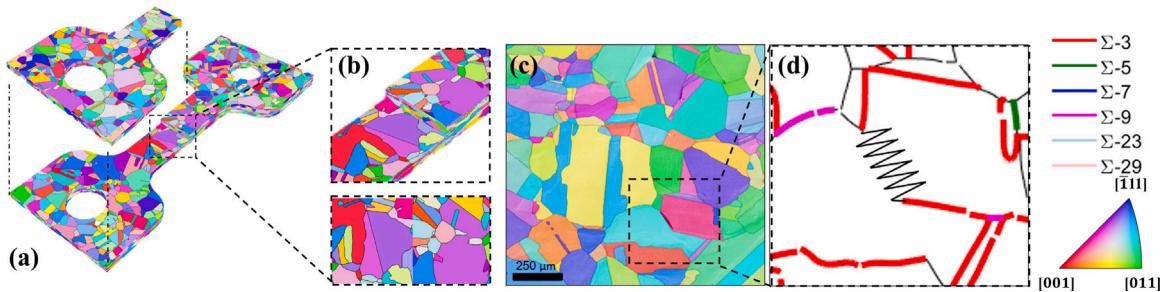
Fig. 2. Surface and bulk intergranular cracking analysis: (a) material removal to expose the bulk, (b) IPF maps of surface and bulk, (c) IPF map of bulk material with a crack, and (d) GB characterization around the crack (depicted by a zigzag line).

All cracks on the surface and bulk material were analyzed by scanning electron microscopy (SEM) and EBSD. Surface cracks were assessed using EBSD scans taken before the specimens were deformed, while for bulk cracks new EBSD maps were performed after fracture. There are roughly 7 layers of grains throughout the sample considering its thickness and average grain size. To characterize the bulk condition, the surface located halfway through the thickness of the sample was used. The bulk material was exposed by grinding to half thickness after the tensile test, followed by polishing with diamond suspensions to $0.25 \mu\text{m}$ and finished with a $0.25 \mu\text{m}$ OPS suspension for further EBSD characterization, as shown in Fig. 2. This procedure ensured that the GBs associated with bulk cracks were not the same as those of surface cracks, as sufficient thickness was removed to reveal a completely new surface of the material.

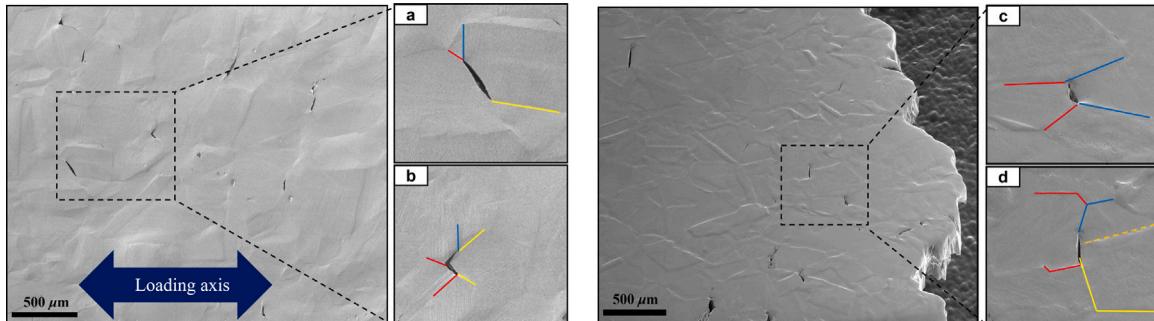
Fig. 3. The longitudinal surface of post-deformation specimens with highlighted cracks: (a) single-GB and (b) multi-GB surface cracks; (c) single-GB and (d) multi-GB bulk cracks after removing half of the material thickness.

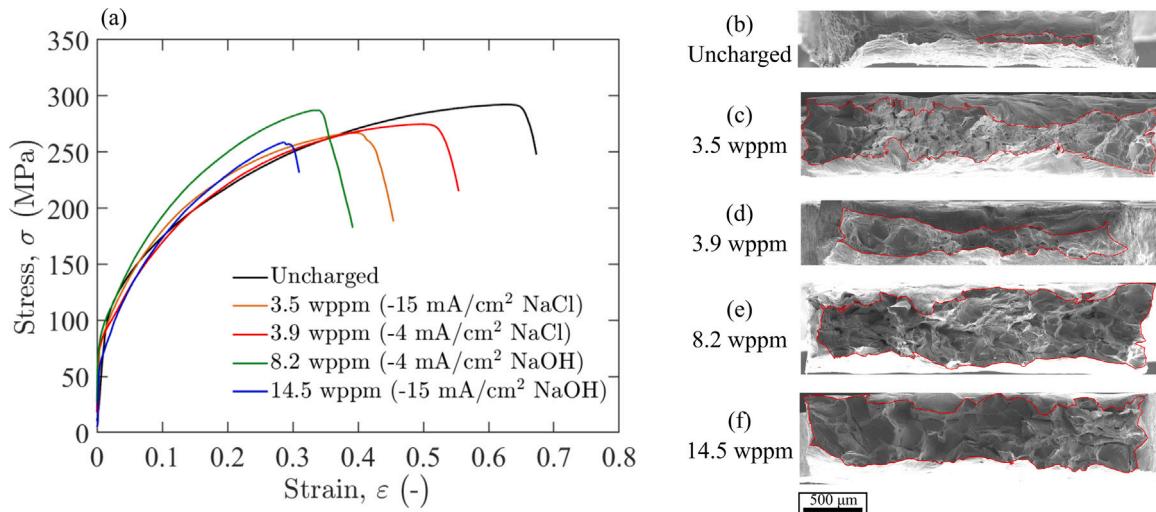
Fig. 4. Engineering stress–strain curves (left) and fracture surfaces (right) of uncharged specimen and specimens with hydrogen concentration of 3.5, 3.9, 8.2 and 14.5 parts per million in weight (wppm).

Tensile tests were performed with specimens charged in all the conditions displayed in Table 1 using a strain rate of 2×10^{-4} s⁻¹, as shown in Fig. 4. All specimens exhibited HE, evidenced by a reduction in the fracture strain (EI_{FS}) relative to the uncharged condition, while no significant changes in work-hardening behavior were observed. HE is also evaluated based on the reduction in area (EI_{RA} , $RA/RA_{\text{Uncharged}}$), and the fraction of intergranular fracture (A_{IG}) on the fracture surface, as can be seen in Fig. 5(a).

The uncharged specimen's fracture surface exhibited extensive evidence of ductile microvoid coalescence and a complete absence of intergranular faceting, consistent with the observed RA of 96%. In contrast, the fracture surfaces of all four cathodic charging conditions show widespread intergranular fracture which increased in area fraction as

hydrogen content increased. Such results are supported by the smaller reduction in area observed for each condition relative to the uncharged baseline. Critically, intergranular fracture was consistently observed in the specimen mid-thickness in all hydrogen-charged cases, despite the presence of mixed failure modes, including intergranular fracture and microvoid growth for the 3.5 and 3.9 wppm (Fig. 5(b)). This mixed failure mode is, to a certain extent, also observed in the sample with 14 wppm where the percentage of intergranular fracture was 65% (Fig. 5(c)). In general, HE indexes (EI_{FS} , EI_{RA} , and A_{IG}) together with the intergranular fracture distribution on the fracture surfaces, especially at 14 wppm, not only confirm that the hydrogen concentration was sufficient to induce significant intergranular fracture, but also suggest a uniform hydrogen distribution within the samples.

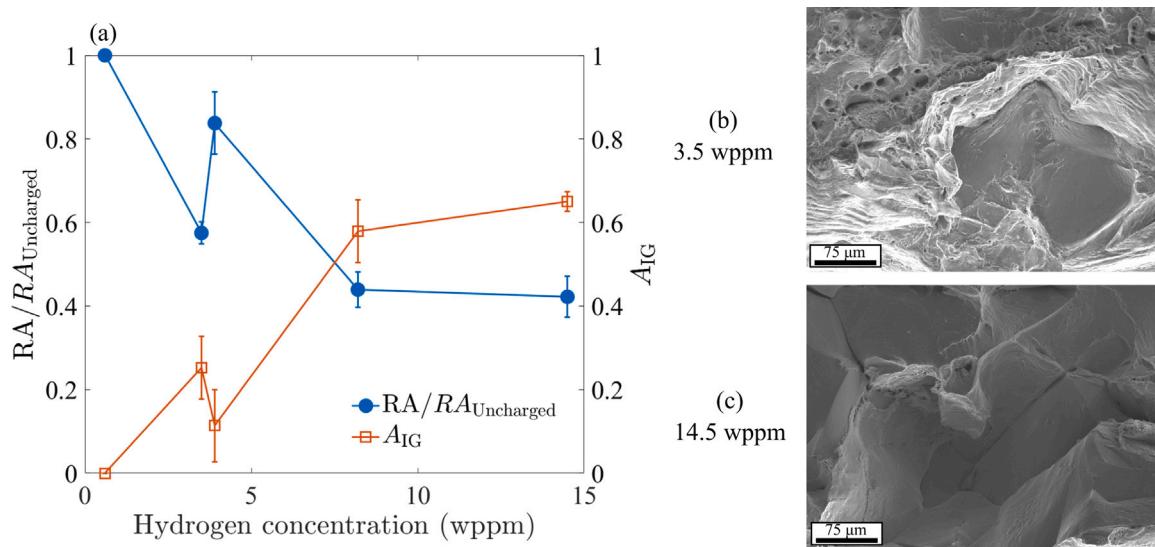
Fig. 5. Quantifying HE in pure Ni: (a) Reduction in area, $RA/RA_{\text{Uncharged}}$, and intergranular area, A_{IG} , as functions of hydrogen concentration, indicating increased embrittlement with higher hydrogen concentration. Fracture surfaces for (b) 3.5 wppm with a mix of microvoids and intergranular fracture, whereas for (c) 14.5 wppm, a larger fraction of intergranular fracture corresponds to a higher embrittlement level.

As expected, embrittlement became more pronounced with increasing hydrogen concentration. Although samples charged with 3.5 and 3.9 wppm showed similar trends in A_{IG} , notable differences in EI_{FS} and EI_{RA} can be observed. A marked increase in A_{IG} was evident between 4 and 8 wppm. However, beyond 8 wppm, the embrittlement level is plateauing, with no further significant changes in EI_{FS} or EI_{RA} , yet showing a 10% increase in A_{IG} . This indicates that a comprehensive assessment of the severity of embrittlement is best achieved by considering the three parameters EI_{FS} , EI_{RA} , and A_{IG} in combination. The trend shown in Fig. 5(a) agrees with previous observations of nonlinear relationships between embrittlement severity and hydrogen concentration, with initially sharp reductions in toughness followed by a plateau at a concentration-invariant toughness [14]. The small differences in HE severity between specimens with 8 and 14 wppm indicate that 14 wppm is probably close to the plateau where the maximum embrittlement level for nickel is reached. On the other hand, the dispersion of the data between 3.5 and 3.9 wppm is likely because, at these hydrogen levels, small differences in concentration between the tensile and TDS samples lead to a larger scatter in HE.

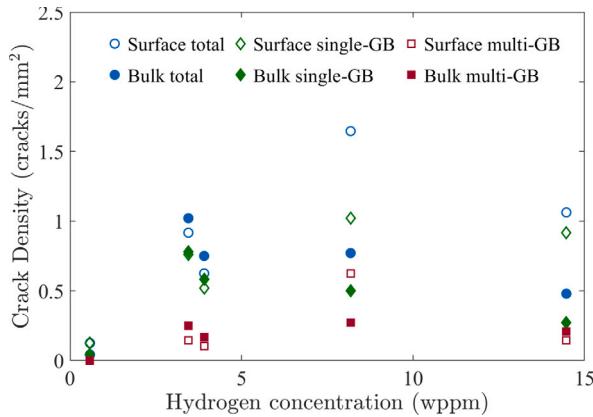
Fig. 6. GB crack densities: total, single-GB and multi-GB crack densities for the surface (hollow symbols) and bulk (solid symbols), considering the average number of cracks observed in the gauge region of two samples for each hydrogen concentration. The crack densities for the uncharged sample are included for comparison.

The number density of intergranular cracks (number of cracks per gauge length surface area, which is 8 mm × 3 mm = 24 mm²) is summarized in Fig. 6. Post-deformation intergranular cracks were rarely observed in the uncharged specimen, with only three surface cracks and one bulk crack detected. On the other hand, there was an average of 15 to 40 surface and 12 to 25 bulk intergranular cracks in the hydrogen-charged specimens, depending on the charging conditions. For the samples with 3.5 and 3.9 wppm, there is a similar number of cracks on the surface and in the bulk material, suggesting that these charging conditions did not induce surface damage. In contrast, there is a substantially larger number of cracks on the surface compared to the bulk material for the samples charged with 8 and 14 wppm. This indicates that more intense hydrogen evolution and/or increased hydrogen absorption during these cathodic charging conditions may facilitate the formation of surface cracks. It is also worth noting that the higher deformation levels attained for the low hydrogen content cases will result in higher hydrostatic stresses at the center of the samples, which could drag hydrogen from the surface and further contribute to

Although there is a difference in the number of cracks between the surface and bulk (Fig. 6), they have similar relative proportions of the types of fractured GBs. This suggests that while cracking may be enhanced by the intensity of cathodic charging, this effect does not alter which types of GBs are more or less susceptible to hydrogen-assisted intergranular cracking. Finally, Fig. 7 also reveals that Σ -low GBs ($3 < \Sigma \leq 29$) have higher post-deformation fracture fractions compared to the baseline microstructure. A detailed analysis (Fig. 8) shows that this is due to the greater susceptibility of Σ -23 and Σ -29, while GBs with lower Σ values (especially Σ -7 and Σ -9) demonstrate resistance to hydrogen-assisted cracking with smaller fractions of fractured GBs than the baseline. This figure combines the fractured GBs within the Σ -low range from all categories (surface and bulk, single-GB and multi-GB) and hydrogen concentrations (low, medium and high).

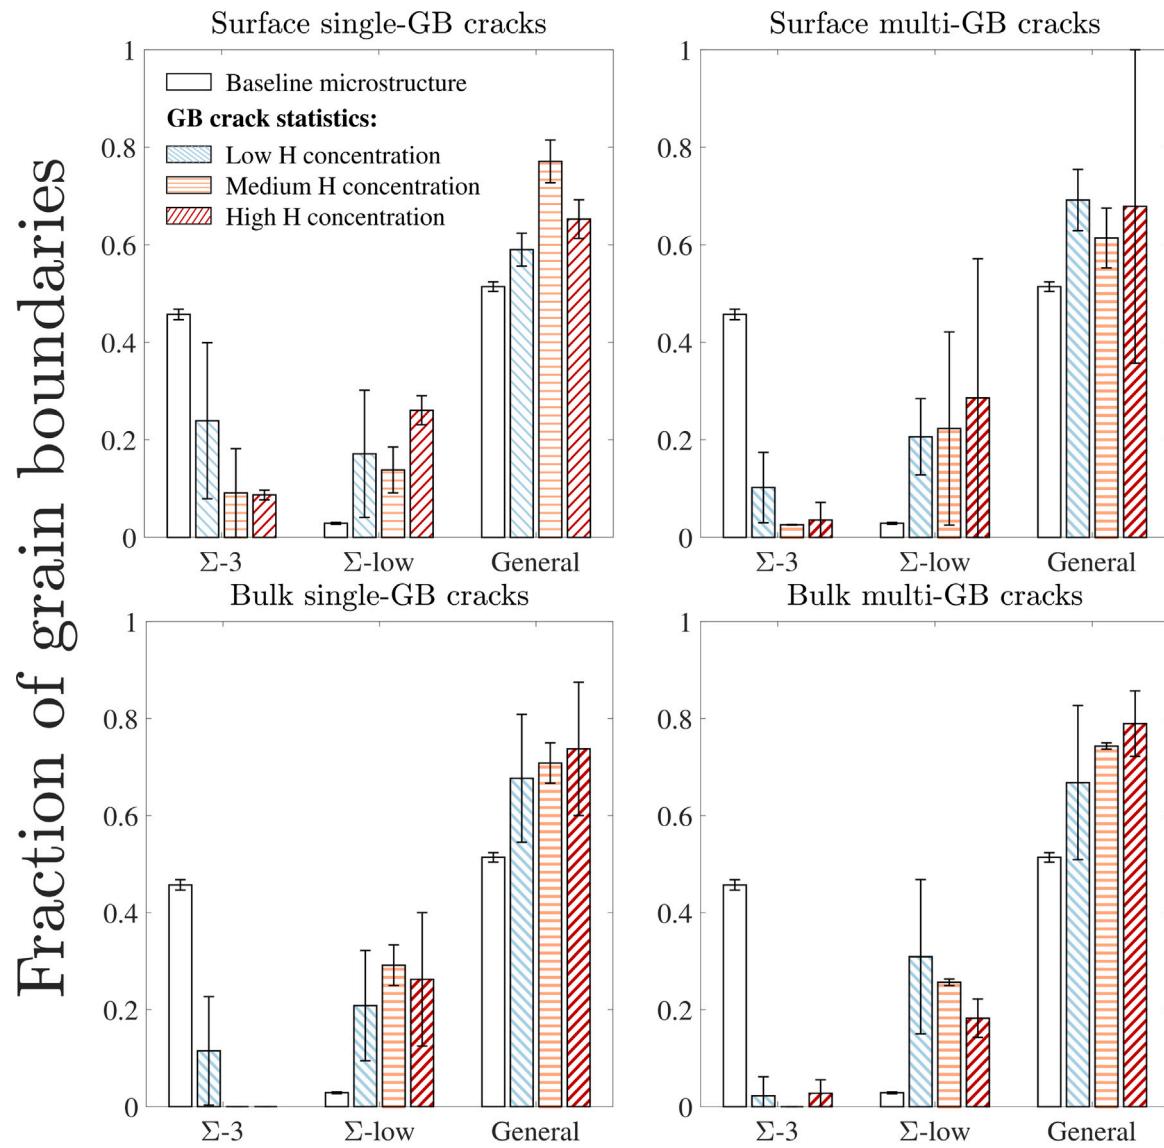
Fig. 7. GB crack statistics compared to the baseline microstructure. The fractions of fractured GBs are shown according to their Σ values, on the surface or in the bulk, involved in single-GB or multi-GB secondary cracks for low (blue), medium (orange), and high (red) hydrogen concentrations. Error bars represent the standard deviation based on all samples for each concentration. The groups of GBs are based on their CSL values, Σ -3, Σ -low ($3 < \Sigma \leq 29$) and general GBs. (For interpretation of the references to color in this figure legend, the reader is referred to the web version of this article.)

The fractions of Σ -3, Σ -low and general GBs are plotted according to their locations, crack categories, and hydrogen concentrations in Fig. 7. The samples charged with 3.5 and 3.9 wppm were grouped for clarity due to the similarity in observed HE levels, fracture surface morphologies, and crack density. Thus, in Figs. 7 to 11, hydrogen concentrations are classified as low (3.5–3.9 wppm), medium (8 wppm) and high (14 wppm). The GB baseline microstructure has an average distribution of $46 \pm 1.1\% \Sigma$ -3, $3 \pm 0.2\% \Sigma$ -low and $51 \pm 1\%$ general GBs. These baseline fractions were obtained from ~ 5000 GBs per specimen. The small variations in the fractions of GBs in the baseline microstructure between all the samples confirms that they had a nominally identical GB distribution before tensile testing.

From the results in Fig. 7, the relative fractions of fractured GBs appear to be independent of their location (surface or bulk) and crack type (single or multi-GB). The Σ -3 GBs consistently exhibit the lowest fraction among the fractured GBs, showing a substantial decrease compared to the baseline, regardless of location, crack type, or hydrogen

concentration. Specifically, Σ -3 GBs accounted for 8%, Σ -low GBs for 24%, and general GBs for 68% of all secondary cracks observed. In addition, the occurrence of fractured Σ -3 GBs decreases with increasing hydrogen concentrations. These findings thus demonstrate that Σ -3 GBs have the highest resistance to hydrogen-assisted cracking at all hydrogen concentrations. This conclusion applies to both crack initiation and propagation, as the fraction of fractured GBs shows no significant difference between single-GB and multi-GB cracks, indicating that susceptibility is independent of the number of GBs involved.

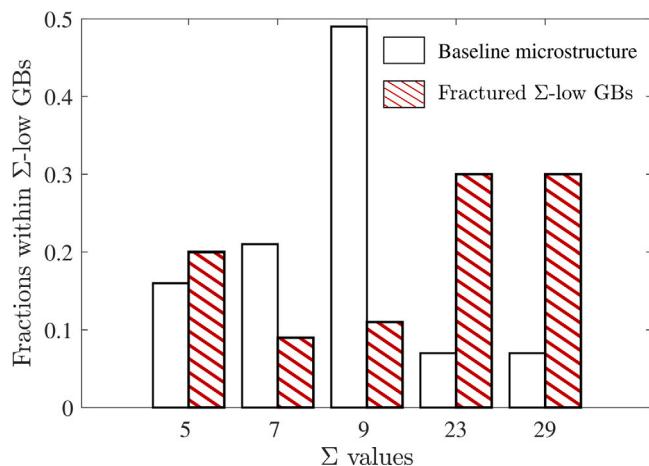
Fig. 8. GB crack susceptibility within the Σ -low category: the distribution of all fractured Σ -low GBs (red diagonal stripes) is compared to the baseline Σ -low distribution (white). Although all belong to the same classification, Σ -23 and Σ -29 GBs exhibit higher susceptibility to hydrogen-assisted fracture.

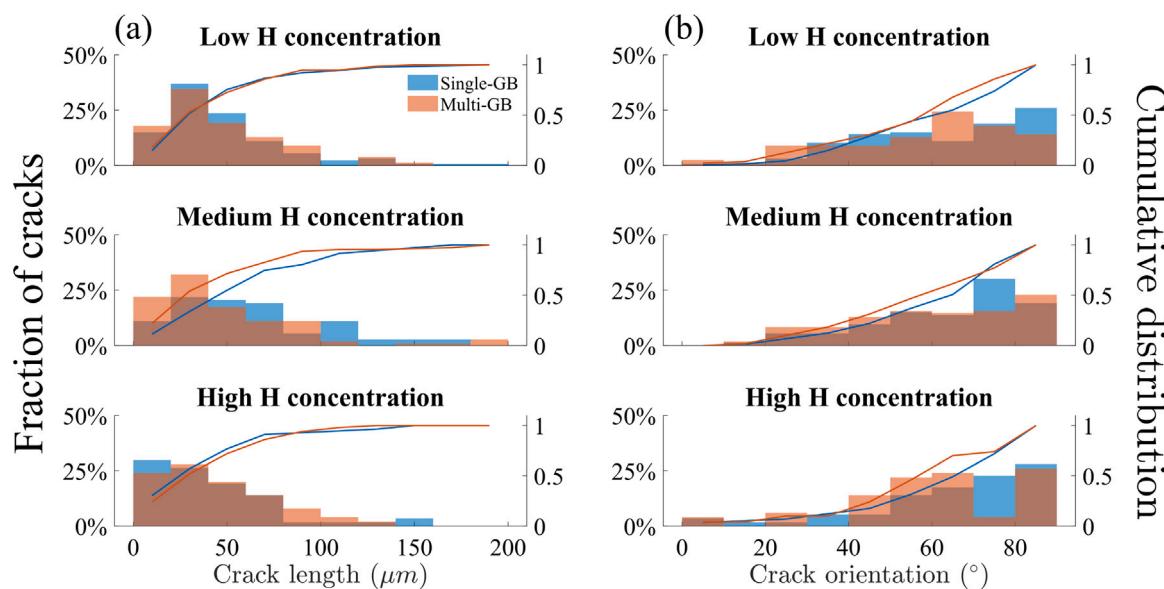
Fig. 9. Geometric properties of the identified secondary cracks: (a) length and (b) orientation angle distributions. The solid lines represent the cumulative distributions.

A summary of the crack lengths and orientation angles of the GBs exhibiting intergranular cracking is presented in Fig. 9. Surface and bulk cracks are combined in this analysis. In Fig. 9(b), a crack orientation angle of 0° indicates alignment parallel to the loading axis, while 90° corresponds to perpendicular alignment. For multi-GB cracks, the angles of all individual GB crack segments are taken into account, i.e. if a multi-GB crack spans two grain boundaries, two crack segment angles are considered. At all hydrogen concentrations, GBs with orientation angles below 20° are rare. Cracks exhibit preferential orientation, with a higher frequency of angles between 70° and 90° , which can be seen to some extent in Fig. 3. Furthermore, hydrogen concentration does not appear to influence crack length distributions for either single-GB or multi-GB cracks, with typical lengths ranging from 20 to 70 μm for both.

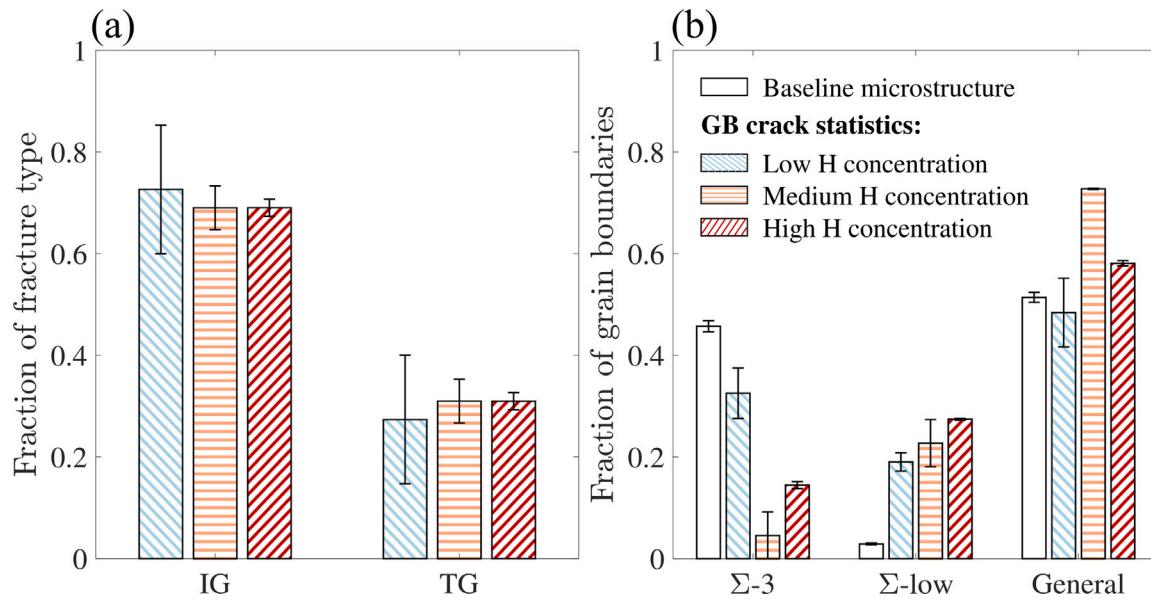
Fig. 10. Fractions of (a) intergranular, IG, and transgranular, TG, in the primary cracks, and (b) GB crack statistics for the IG cracks compared to the baseline microstructure. Error bars represent the standard deviation based on all samples for each concentration.

samples. The primary cracks exhibit a combination of intergranular (IG) and transgranular (TG) fractures. The fractions of these two failure modes and of GBs in the IG cracks are shown in Fig. 10. There are around 70% IG and 30% TG for all the studied hydrogen concentrations. Similar to secondary cracks, the Σ -3 GBs consistently show the highest resistance to hydrogen-assisted intergranular cracking. The IG crack length for primary cracks is comparable to that of secondary cracks, generally ranging from 20 to 70 μm (Fig. 11(a)), while TG cracks exhibit greater variability in length. The orientation angles of the fractured GBs show a more pronounced trend around 80° and 90° (Fig. 11(b)), especially for medium and high hydrogen concentrations, reinforcing the contribution of decohesion to the cracking of these interfaces.

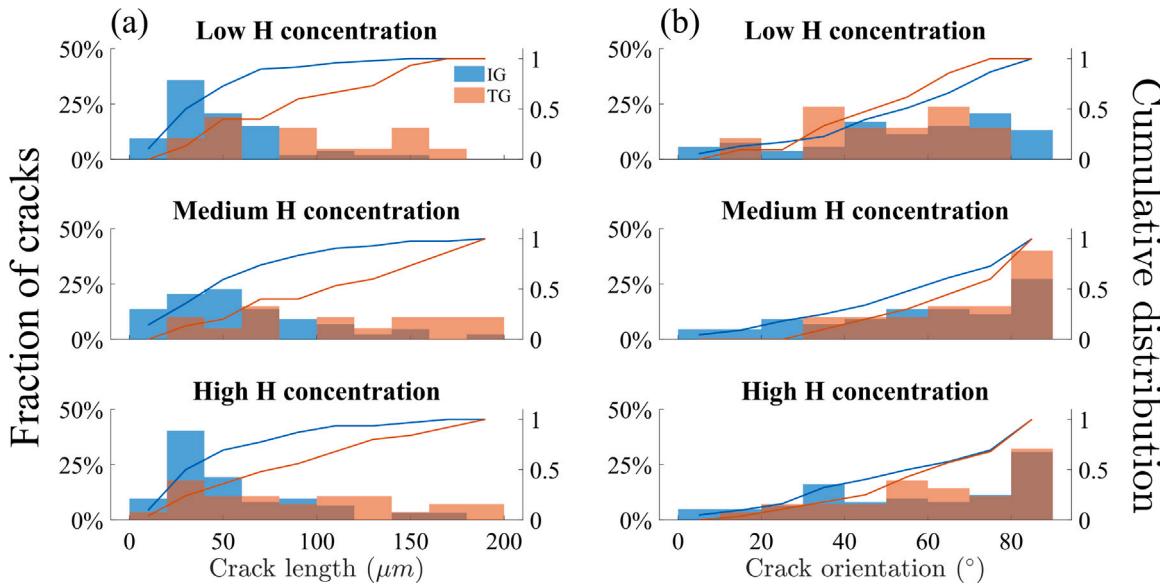
Fig. 11. Geometric properties of the identified primary cracks: (a) length and (b) orientation angle distributions. The solid lines represent the cumulative distributions.

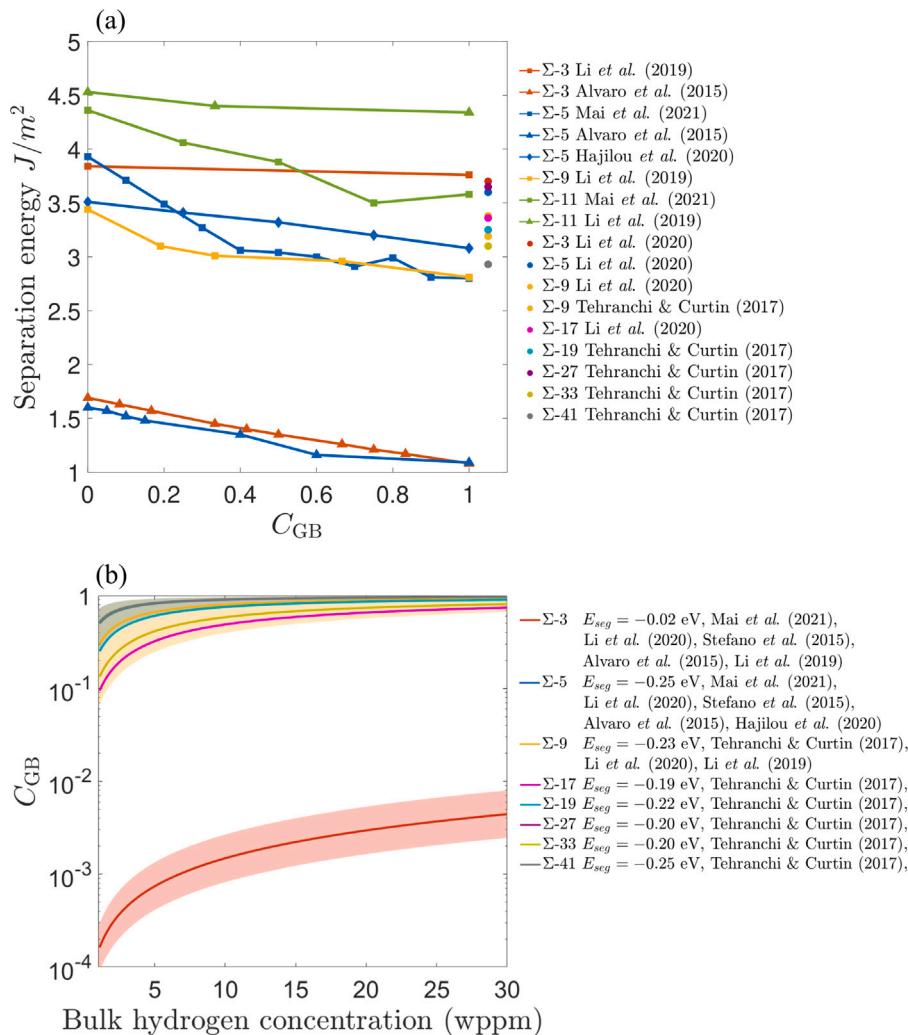
Fig. 12. (a) GB separation energy as a function of hydrogen coverage from DFT and MD simulations [26,29–31]. The circles indicate conditions under which near full hydrogen coverage at the GB is achieved for a given bulk atomic concentration of 0.001 (17 wppm) [25,27]. (b) Hydrogen coverage at grain boundaries as a function of bulk hydrogen concentration. The shaded areas represent variations in coverage due to different segregation energies reported in the literature [25–31]. The mean segregation energy values considered are given in the legend. For works where multiple values are provided, the highest segregation energy is used for each GB type.
